Intake Structure Repairs

Assess and repair, as necessary, the intake structures at J.H. Fewell and O.B. Curtis.

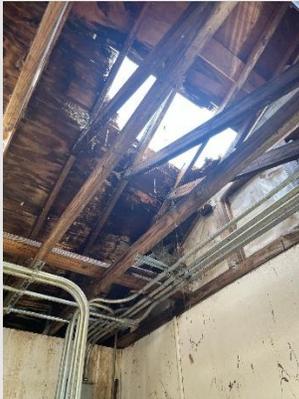
Damage to the roof at the intake building at O.B. Curtis

- Repaired the roof and lighting for O.B. Curtis
- Performed a structural inspection of the intake support structure below the water line at O.B. Curtis
- Rehabilitated the permanganate feed system

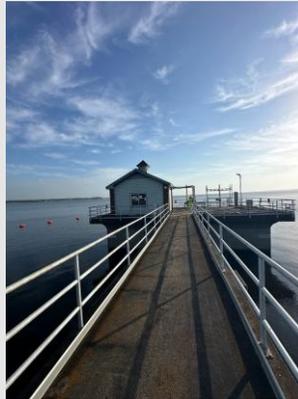
The repaired intake building at O.B. Curtis

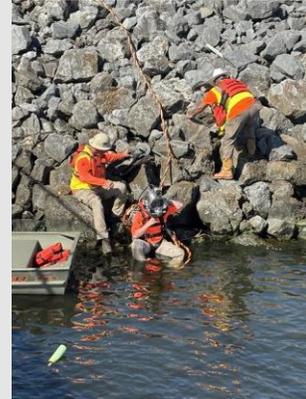
A diver preparing to inspect the intake structure at O.B. Curtis
